Audi > R8 > 2008

Electrical Equipment

94 - Removal and Installation

Front Side Marker Lamps

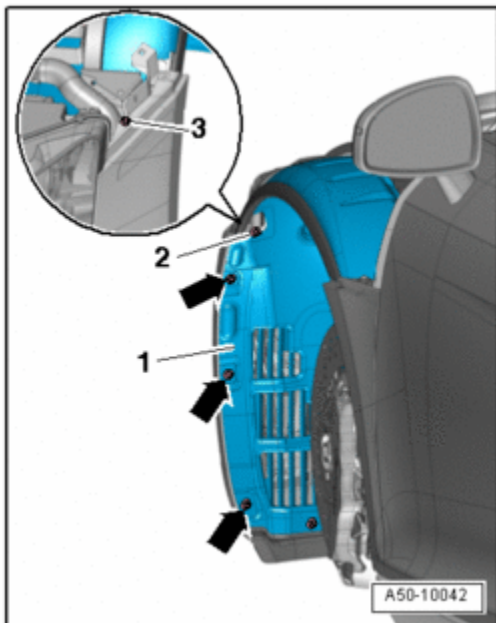
- Remove screws - **arrows** - .

- Move loosened part of wheel housing liner - **1** - to side.

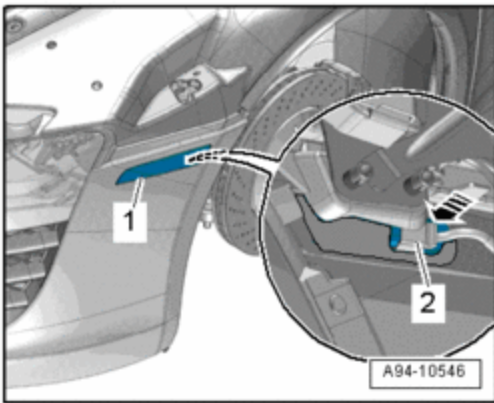
- Reach behind bumper cover and press light - **1** - out of bumper cover - **arrow** - .
- Disconnect electrical connection - **2** - .

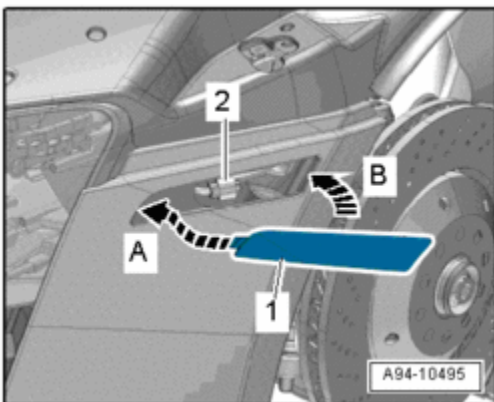
- Insert guide in mount on bumper cover - **arrow A** - .
- Connect electrical connection - **2** - and press cornering light - **1** - into bumper cover until it engages audibly - **arrow B** - .
- Install screws for front wheel housing liner ⇒ Body Exterior - Repair Group 66 .
